**Lead & Asbestos Issues with the new  
National Museum of African American  
History & Culture (NMAAHC)  
Artifacts and Collections**

- Hayes C. Robinson, III, M.S.,  
Associate Director for Environmental Management Division, Smithsonian OSHEM
- Sophia Kapranos, Industrial Hygienist, Smithsonian OSHEM

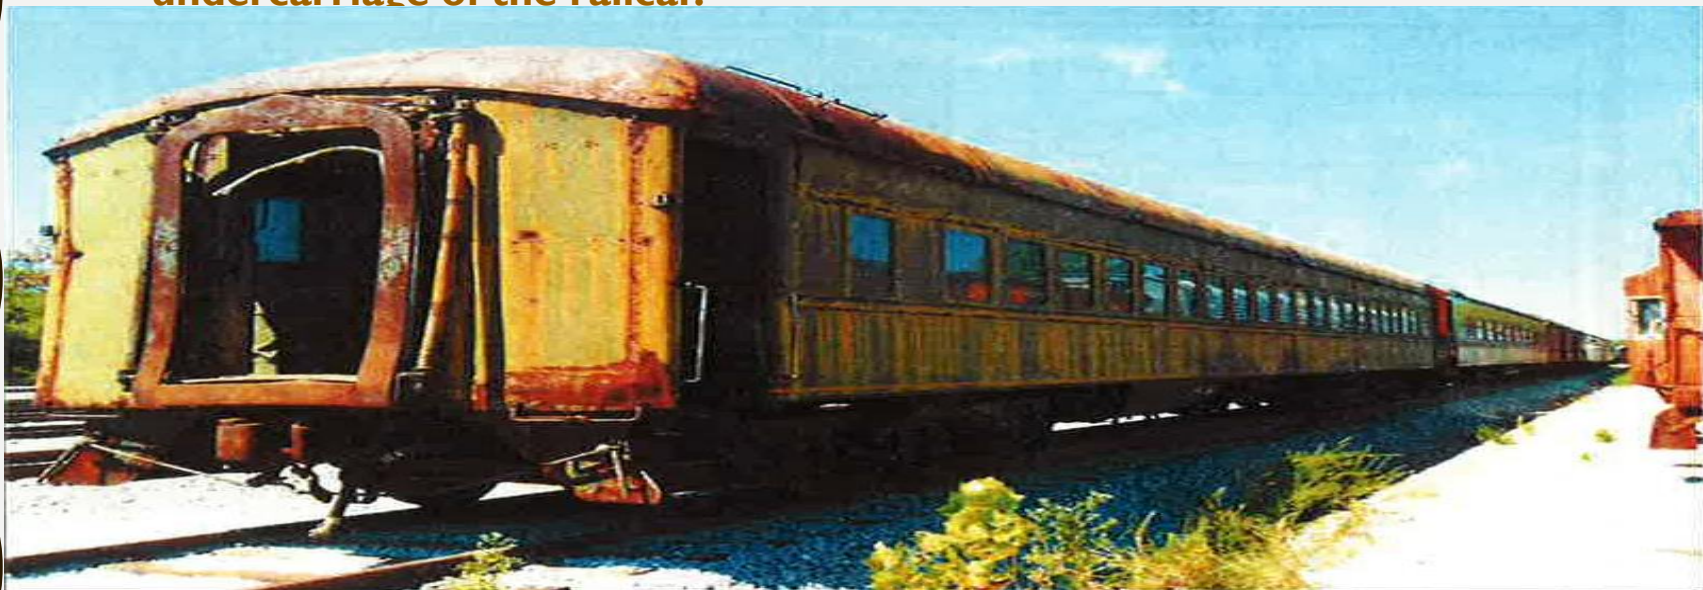
## ❖ Jim Crow Era Railroad Car

- Both Lead-based paint & Asbestos-containing materials were discovered.
- Both Exterior & Interior Painted Surfaces were in poor condition.
- All sampled components revealed elevated concentrations of Lead (Pb) (In excess of 5,000 parts per million).
- Thermal system insulation (TSI) pipe wrap was discovered on the undercarriage of the railcar.

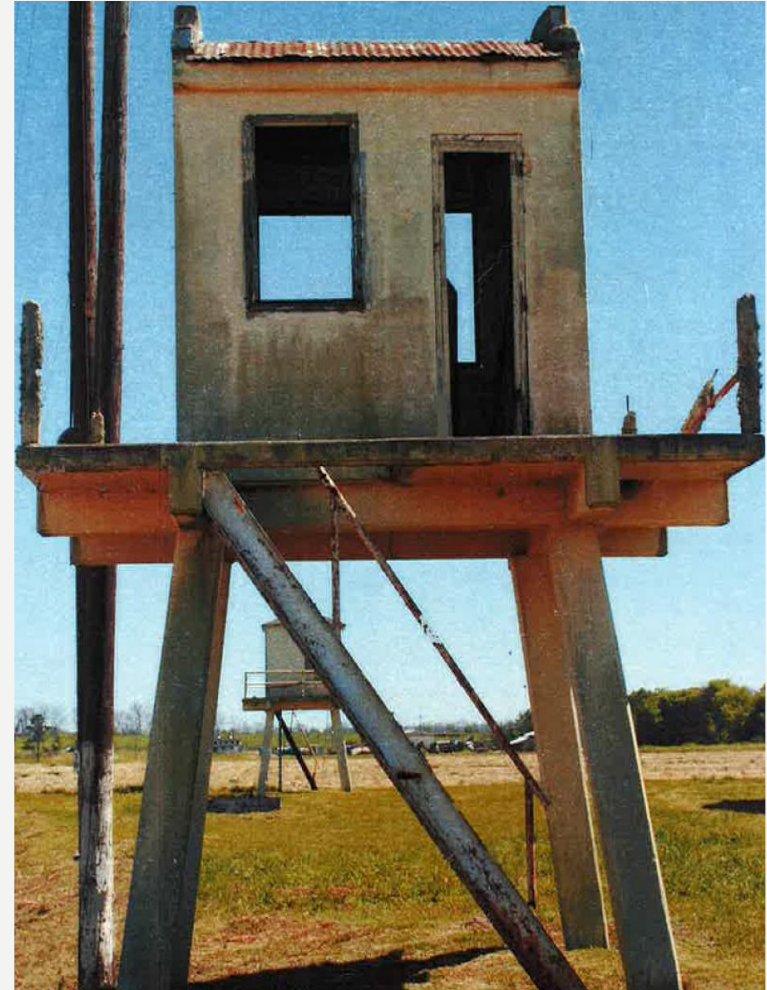
# Louisiana State Penitentiary (Angola) Prison Guard Tower

- **Asbestos-containing materials were discovered on the guard tower.**
- **Black roof flashing (2% Chrysotile)**
- **Black window frame flashing (6% Chrysotile)**
- **Bulk paint chip samples were collected from the guard tower and none were considered to be lead-containing.**

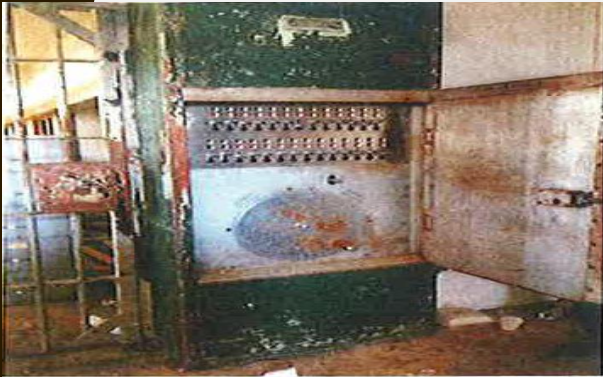
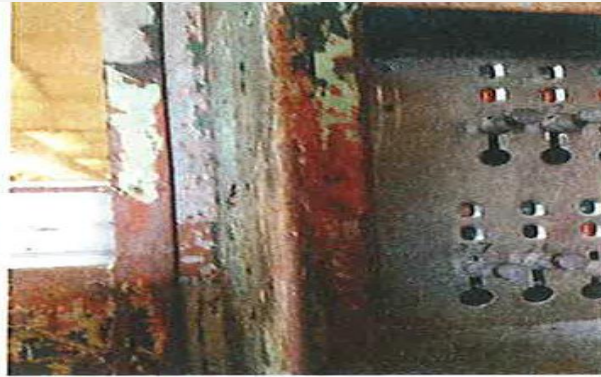
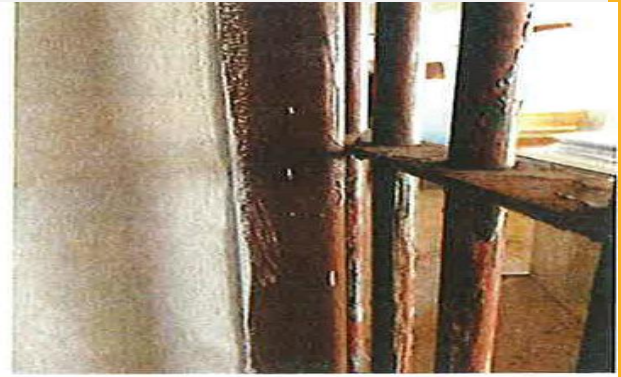
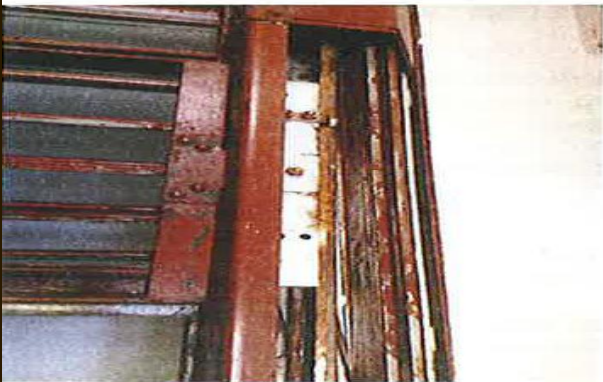
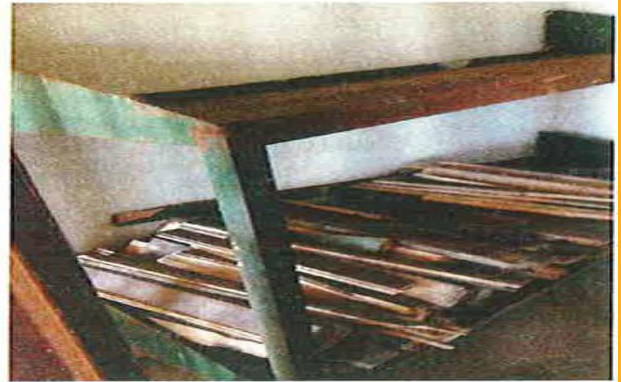
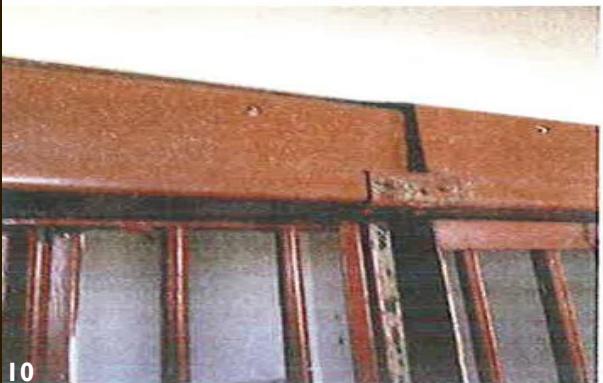
# Angola Prison Jail Cell

- Paint chips collected from the ceiling and a beam within the prison cell, revealed the presence of lead-based paint.
- Recommendations were made to utilize licensed abatement personnel to abate lead-based paint before delivering to NMAAHC.

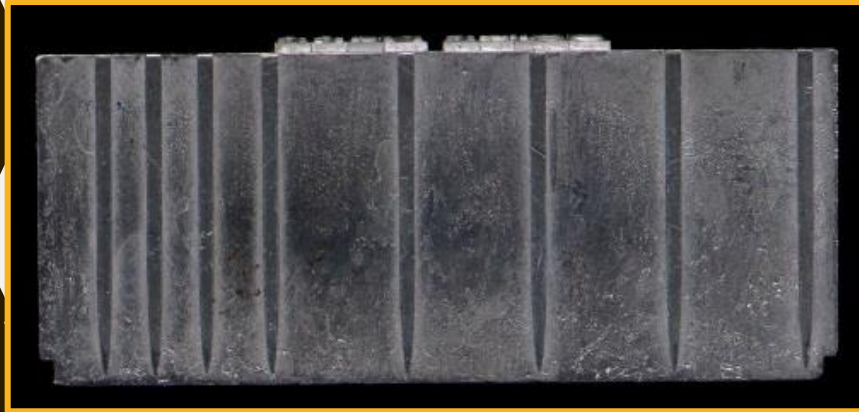
**Molded type slug**

side view

Recommended  
and/or encaps

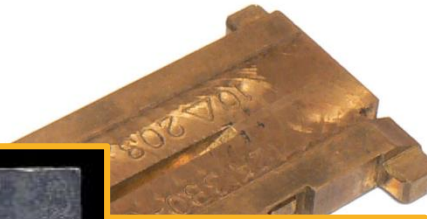
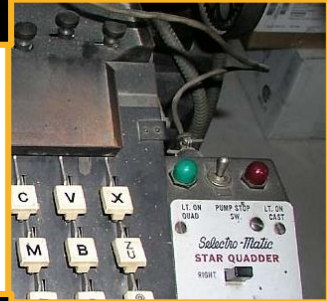
# Chicago Defender Linotype

Matrices assembled with spacebars

- ❖ Lead source from molten lead alloy used to cast a line of type called a “slug”
- ❖ September 16, 2011, OSHEM lead wipe sampling
- ❖ 2 lead abatement efforts (contractors)
- ❖ Lead permanently embedded in wood, grease, coated on metal components, etc.
- ❖ OSHEM recommendations:
  - Encapsulation
  - Enclosure
- ❖ June 15, 2016, lead in air sampling conducted inside and outside the exhibit

**NMAAHC Office of Collection  
incorporated BOTH recommendations**

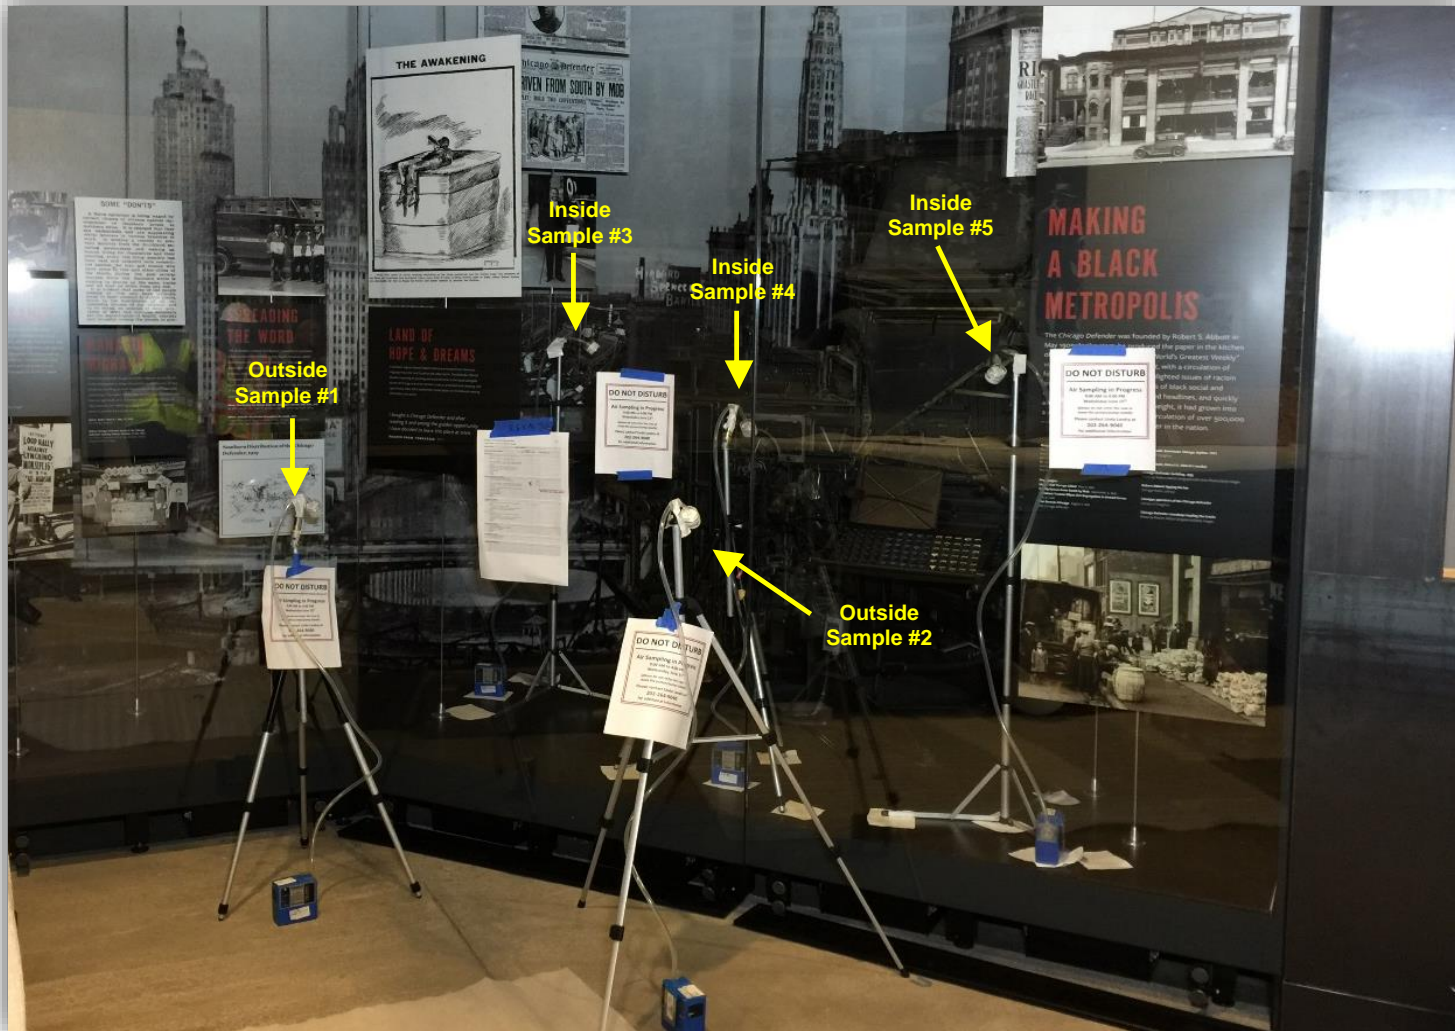
# Chicago Defender Linotype

Air sampling locations: Linotype object in Chicago Defender exhibit (case #PP09.02.ca.01)
